DEPARTMENT OF TRANSPORTATION

Quality Assurance and Source Inspection

Contract #: 04-0120F4Cty: SF/ALA Rte: 80 PM: 13.2/13.9File #: 70.28**WELDING INSPECTION REPORT****Resident Engineer:** Pursell, Gary**Address:** 333 Burma Road**City:** Oakland, CA 94607**Report No:** WIR-005569**Date Inspected:** 02-Mar-2009**Project Name:** SAS Superstructure**OSM Arrival Time:** 830**Prime Contractor:** American Bridge/Fluor Enterprises, a JV**OSM Departure Time:** 1630**Contractor:** Japan Steel Works**Location:** Muroran, Japan**CWI Name:** Chung Kuan**CWI Present:** Yes No**Inspected CWI report:** Yes No N/A**Rod Oven in Use:** Yes No N/A**Electrode to specification:** Yes No N/A**Weld Procedures Followed:** Yes No N/A**Qualified Welders:** Yes No N/A**Verified Joint Fit-up:** Yes No N/A**Approved Drawings:** Yes No N/A**Approved WPS:** Yes No N/A**Delayed / Cancelled:** Yes No N/A**Bridge No:** 34-0006**Component:** Tower, Jacking and Deviation saddles**Summary of Items Observed:**

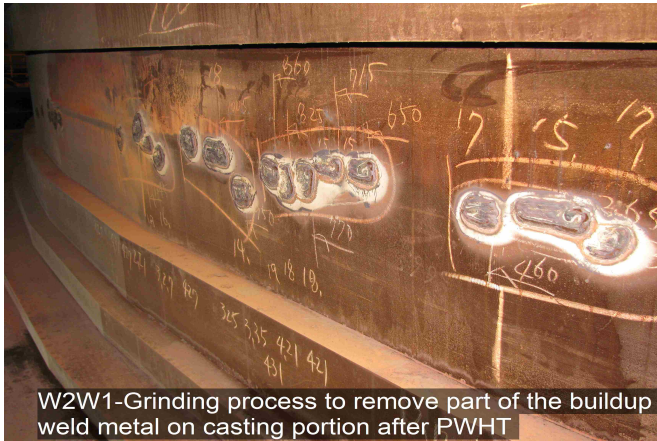
W2-W1 West Deviation Saddle Casting: Caltrans QAI observed a welder perform grinding process on all of the buildup weld metal after PWHT of W2-W1 west deviation saddle casting. The purpose of grinding is remove all the excess weld metal before NDT performing. Based on Caltrans observation, no discrepancies were noted.

W2W1-Grinding process to remove part of the buildup weld metal on casting portion after PWHT

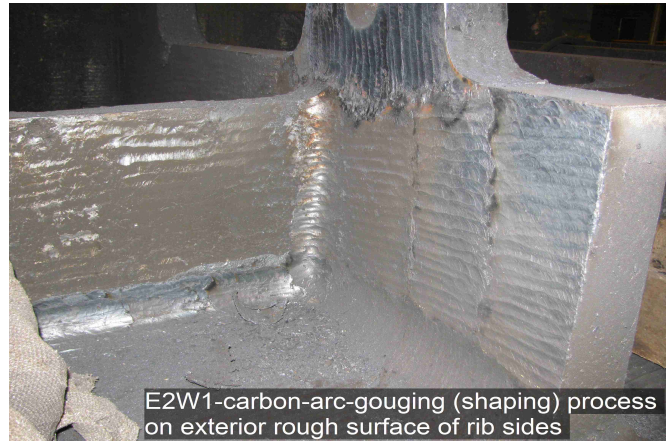
E2W1 East Deviation Saddle Casting (shaping): Caltrans QAI observed one welder perform carbon arc gouging

(shaping) process on exterior rough surface of rib sides of E2-W1 east deviation saddle after rough machining. The gouging purpose is the exterior rough surface areas are not uniform surface and not able to use machining and remove all of exceed metal from the rib areas. The equipment used for gouging is manual torch with 10mm gouging electrode all made in Japan. The gouging process will continue for two week. Based on Caltrans observation, no discrepancies were noted.

E2W1-carbon-arc-gouging (shaping) process on exterior rough surface of rib sides
